Environmental Stress cracking of polymers: case studies from industry (ABS and LDPE)

Thomas Doohar, Abu Saifullah, Jawad Ullah, Ciaran Magee, Adrian Mulholland & Dorian Dixon

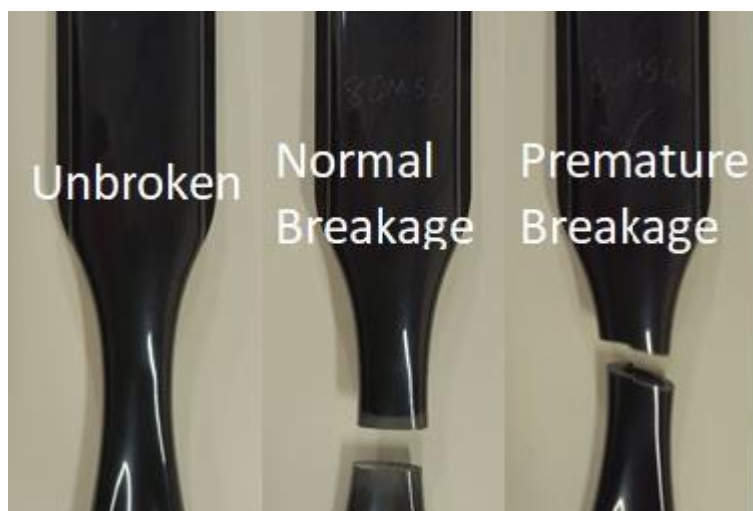
Figure 1. Breakage of the samples

A photograph of parts after tensile testing is shown in Figure 1 and it is apparent that exposure to Grip-It™ can alter the failure behaviour. Normally breakage occurred at the thinnest portion of the part in a ductile manner with evidence of necking and an area of white grazing extending ~5mm at either side of the failure. However, in the parts which failed prematurely after exposure to Grip-It™, the breakage occurred at the interface between the solid and hollow section. After exposure to Grip-It™ the parts failed in a brittle manner which matches reports of ESC in literature[8].

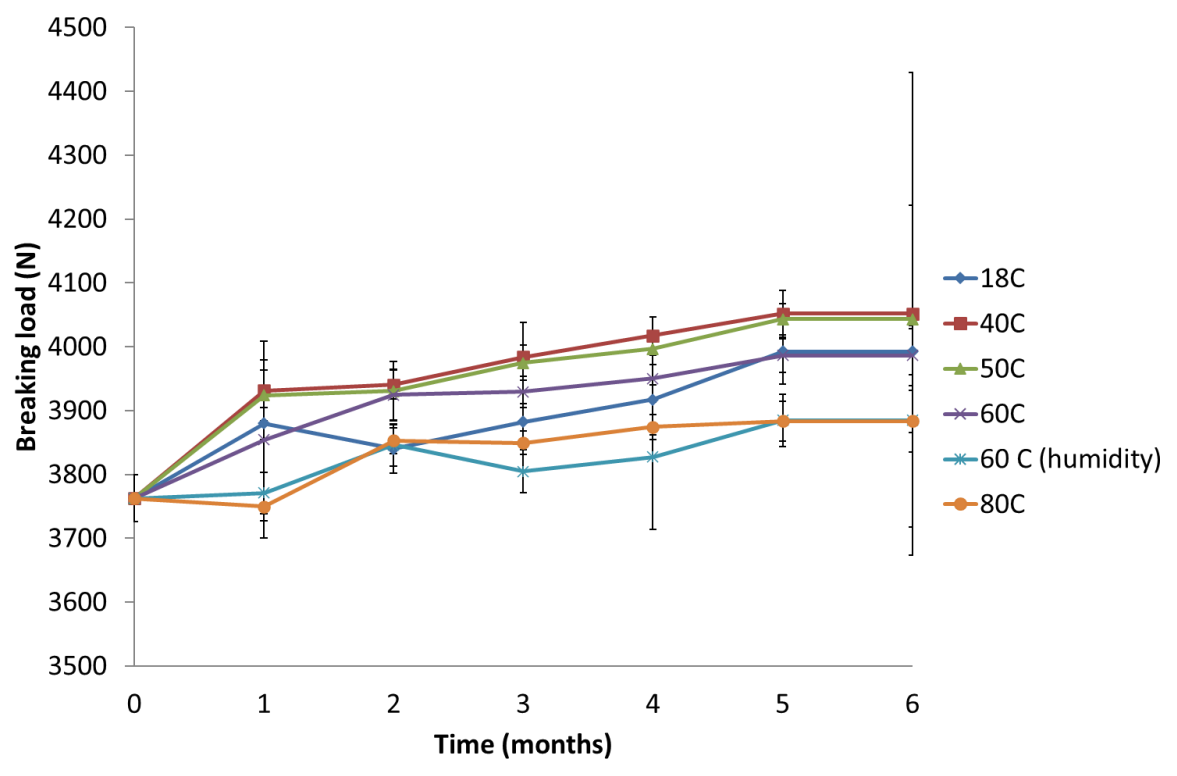
Figure 2. Breaking load of the parts (not exposed to Grip-It)

The breaking load of the parts without Grip-It™ can be seen in Figure 2. It would appear that the parts have a slight increase in the breaking load as a result of the exposure to elevated temperature. Thermal ageing has been reported to improve the tensile strength and modulus of polymers including ABS but with reductions in toughness as a result of embrittlement [1]. In the case of ABS these changes during storage at elevated temperature have been attributed to a number of factors including cross linking at the part surface [17]. The relaxation of residual stress from the injection moulding process may also play a role. All of the as-received parts tested broke in the expected region of the part with none displaying premature brittle failure. The results for the parts which were exposed to Grip-It™ can be seen in Figure 3. A significant drop in the breaking load of the parts was noted compared to the parts which were not exposed to Grip-It™. The error bars in the graph are large because the parts either broke normally (at a similar load as the samples which were not exposed to Grip-It™) or at a much lower load (approximately 600-700N) due to premature failure. It was found that in addition to the samples breaking at a much lower load due to premature breakage, the location of the break also changed and occurred in the hollow section. The average standard deviation in breaking load of the parts which were not exposed to Grip-It™ was approximately 60N; whereas for the parts exposed to Grip-It™ was approximately 660N. These results confirm the apparently random nature of ESC. There did appear to be some temperature dependence with parts aged at 18°C displaying the smallest reduction in breaking load, suggesting that elevated temperature accelerate ESC. The samples aged in the humidity chamber also showed a lower reduction in

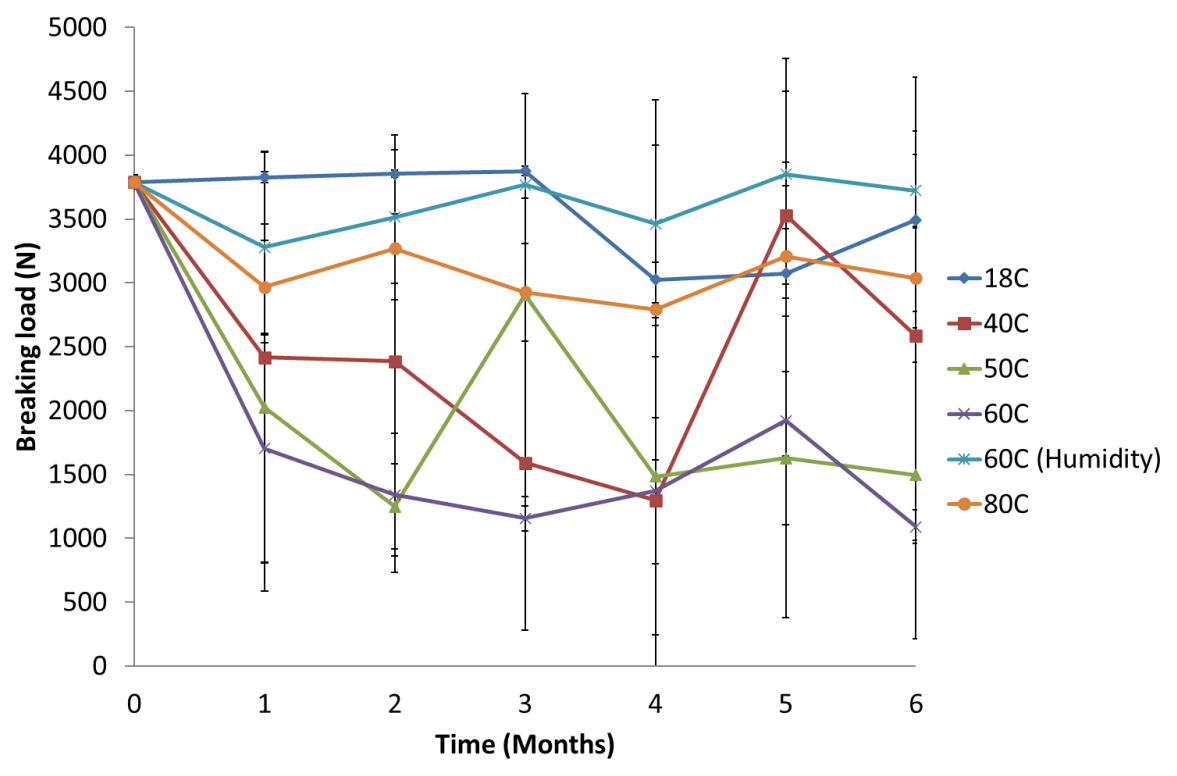
Figure 3. Breaking load of the parts (exposed to Grip-It)

mechanical performance when exposed to Grip-It™ compared to the samples aged at the same temperature at ambient humidity. Other researchers have reported a reduction in the stiffness of ABS when aged in a humid environment [18,19]. It is likely that the moisture is absorbed into the acrylonitrile component of ABS [20–22] and acts as a plasticiser protecting against ESC to some extent.

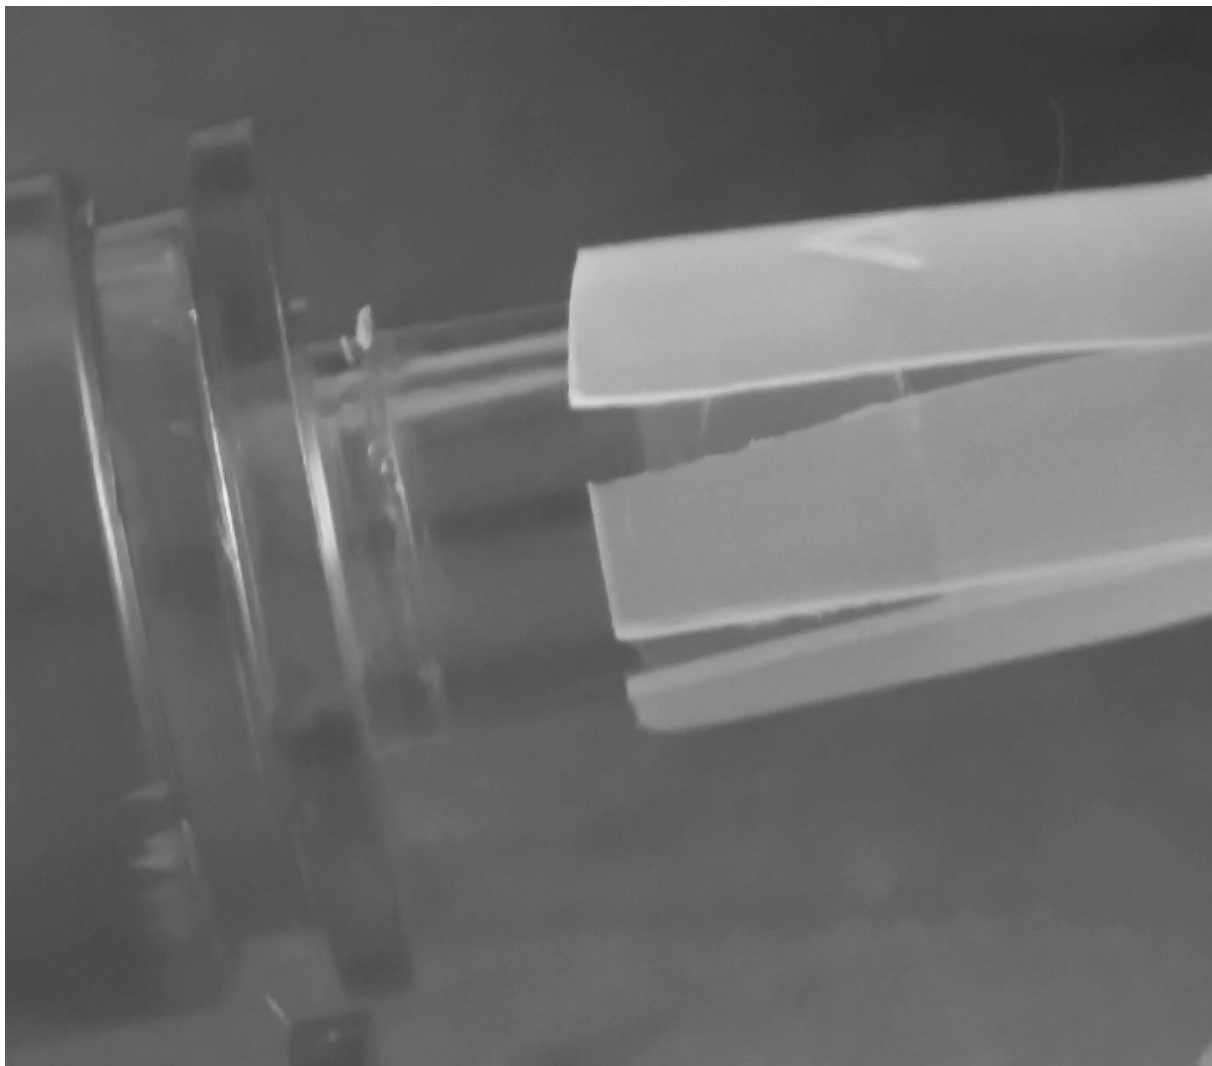
Figure 4. Failure of the LDPE medical tubing

The company involved in this case study produce respiratory tubing for anaesthesia machines and ventilators. These supply respiratory gases, including vaporous anaesthetic agents in addition to oxygen and medical air. These gases can be dry or humidified. The tubing assembly comprises a flexible tubing limb with an integrated connector which push-fits onto corresponding connectors on the equipment. During assembly, Isopropanol (IPA) was wiped over the ends of the connectors before fitting the connectors to the tubing to make it easier to fit the parts together. It was found that after assembly and on occasion in-service, that some of the connections between the tubes and/or the tubes and the respirator displayed visible cracking leading to potential failure of the joints. This can be seen in Figure 4. While the company was not aware that the issue may have been caused by ESC, they did suspect that using IPA was playing a role. Prior to this project, the company tried altering the composition of the tubing and the assembly solvent in an attempt to overcome the issue.

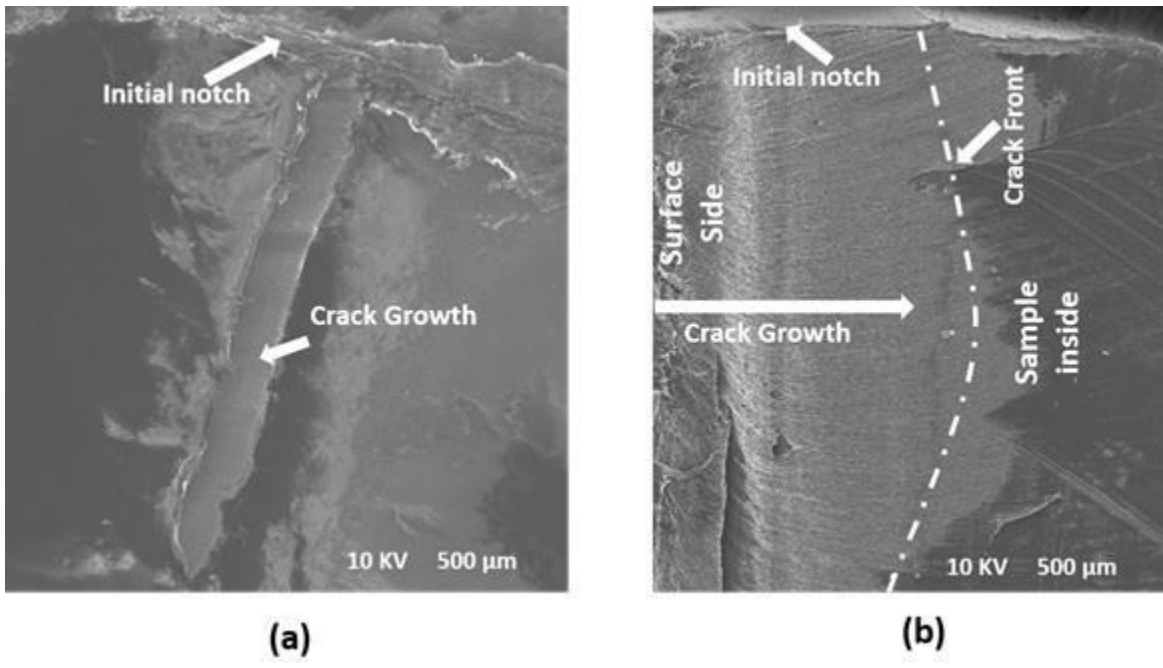
Figure 6. SEM of the LDPE samples exposed to MEK

Figure 6 shows a SEM image of environmental stress cracking which occurred in the LDPE sample during ESC testing via ASTM D1693. It was observed that the crack grew perpendicular to the initial notch. The crack begins at the surface and propagates into the samples. Brittle fracture features were observed and no clear fibrillation or crack ridges to slow or stop the crack growth were apparent on the fracture surfaces. It has been reported that smooth crack surface is a typical characteristic of ESC [22]. These observations were supported by previous studies, where it was concluded that ESC is a brittle failure, starting from the surface due to the creation of micro-voids and cracks by the surface-active liquids or agents [6,11,27,28].

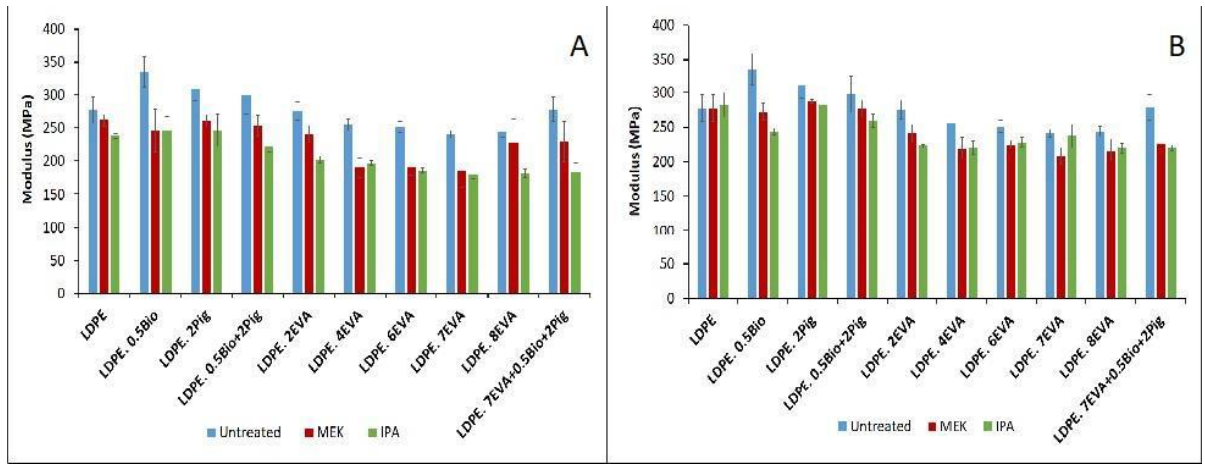
Figure 7. Tensile modulus of the polymer blends (A painted on, B dip in)

ISO bent strip testing was conducted in accordance with ISO 22088-3 to assess the effect of ESC on the mechanical properties of the blends with the unaged LDPE blends as a control. It was found that no cracks or failures were observed in any of the samples after 1000hrs/42 days. This is in contrast with the samples aged used in the ASTM standard and is attributed to lower strain which was applied to the samples during the ISO ageing process. It was also found that there were no significant changes in the strength of the samples (for each polymer blend) when exposed to either liquid (regardless of whether it was applied by dipping them in the liquids or painting it on). However, the stiffness of the samples was found to change when they were exposed to the two solvents. The Young's modulus of the samples which were dipped in the liquids can be seen in Figure 7.A and the Young's modulus of the samples which had the liquids painted on can be seen in Figure 7.B. Interestingly, the data suggests that the additional of the Biocote and pigment increased the stiffness of the samples potentially rendering the material more susceptible to ESC failure. It is clear from both sets of data from Figure 7 that the presence of the two solvents lead to a significant drop in the Young's modulus, with IPA having the largest impact. The addition of increasing percentages of EVA reduced the Young's modulus of the blend which was expected as it is an elastomer and this reduction in stiffness could help protect against ESC. In agreement with the data from the ASTM tests it can be seen that the presence of the pigment and Bio-cote appear to have a determinantal effect on the ESC resistance. The effect of the MEK and IPA on Young's modulus are similar with some of the samples displaying a smaller drop in stiffness with MEK compared to that seen with IPA.
