# IS THE QUALITY OF CEMENT A CONTRIBUTING FACTOR FOR BUILDING COLLAPSE IN GHANA?

Sub-standard (poor quality) materials have been mentioned as one of the major causes of building collapse worldwide. The main materials mostly identified as sub-standard are cement, reinforcement bars, timber and aggregate. This Paper assesses whether the quality of Type I Portland cement use in Ghana - contribute to the recent building collapse in Accra and Kumasi. This was achieved through experimental study by comparing the properties of Ghana cement with that of UK cement. The study found that the dry density of Ghana Grey cement was higher than both the UK Grey and UK White cements. Furthermore, the Ghana Grey cement performed better in resistance to water absorption than UK Grey cement, while the UK White was better than both Ghana Grey and UK Grey cements. In addition, while UK White cement performed better in compression than Ghana Grey and UK Grey cements, the Ghana Grey was better than the UK Grey cement. The results of the experiment clearly reveal that the quality of Ghana's cement is comparable to that of UK. Therefore, the paper concludes that the quality of Ghana's cement might not be t

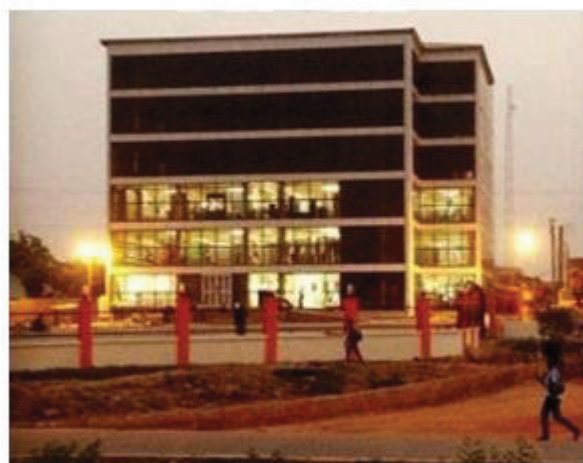
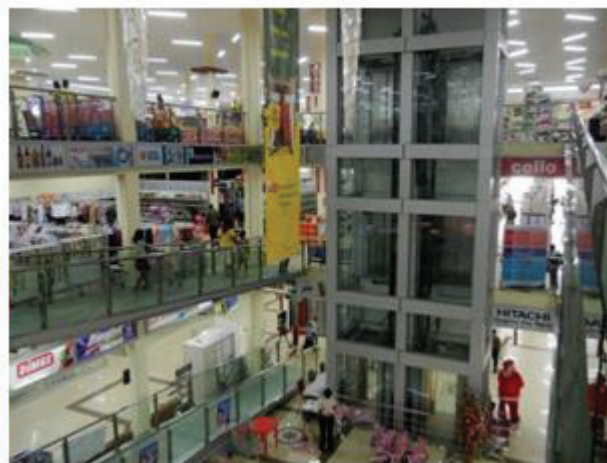
### Figure 1: Melcom Shopping Mall Building before Collapse

*External View before Collapse*

*Internal View before Collapse*

The appearance of the building before collapse is presented in Figure 1 and after the collapse can also be found in Figure 2. The building experienced a total collapse with all the structural components falling down. This accounted for the high fatality rate.

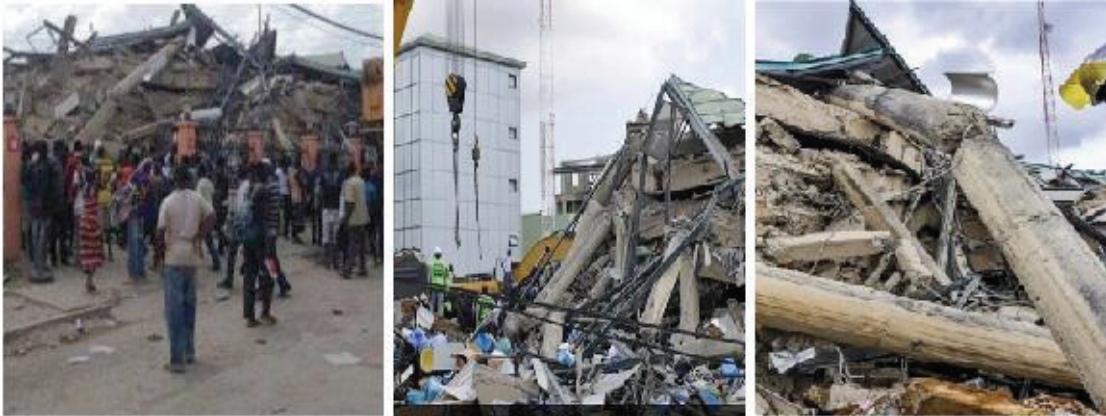
### Figure 2: Melcom Shopping Mall Building after Collapse

*External View of Building after Collapse*

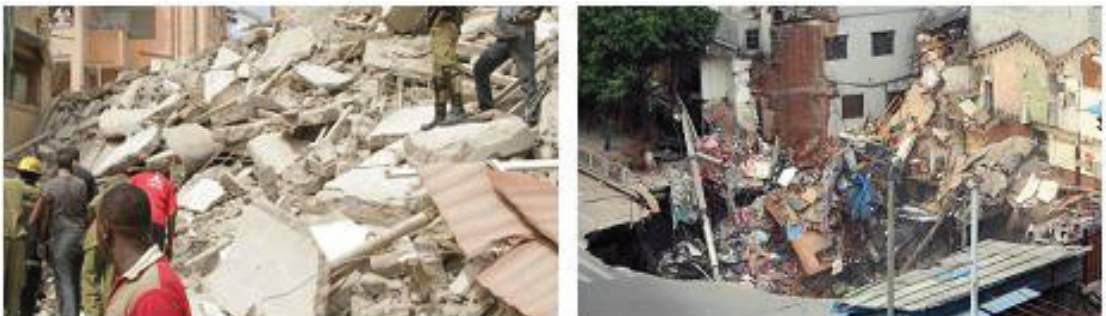
### Figure 3: Krofrom Three-Storey Residential Building after Collapse

A very recent incident of building collapse in Ghana was the three-storey residential building situated at Krofrom, a suburb of Kumasi, the Ashanti regional capital, which collapsed on Monday, April 15, due to a heavy downpour of rain trapping many people under the rubble. 3 people were confirmed dead while 5 others sustained various injuries. Figure 3 presents the external view after the collapse of the building.

*External View of Building after Collapse*

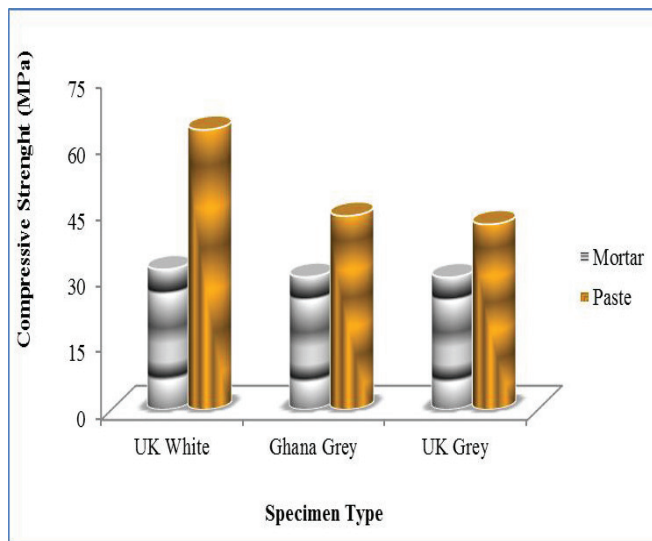
**Figure 6:** Comparison of Compressive Strength Results

The compressive strength test results comparison is presented in Figure 6. The results show that the Ghana Grey cement had less than 1% and 5% increase in compressive strength for mortar and cement paste respectively than UK Grey cement specimen. The UK White cement on the other hand, recorded higher compressive strength than both Ghana Grey and UK Grey cement specimen. It can be concluded that while UK White cement performed better in compression than Ghana Grey and UK Grey

cements, the Ghana Grey was better than the UK Grey cement. Building contractors and other practitioners in the construction industry as well as academicians in Ghana should therefore know that the cement produce in Ghana have good resistance under the influence of a compression stress.
