# Climate change and evolution of landslide hazard at Nefyn Bay, North Wales.

**ABSTRACT:** An essential tool in the management of present slope instability is understanding the climatic history of an area, and how this relates to the deposition and stability of sediments. Late Pleistocene and early Holocene climatic changes have had a significant influence upon sediment deposition and subsequent modification, and this has a direct bearing on Holocene coastal landsliding that continues to the present day. The cliffs of Nefyn Bay, on the northern coast of the Llyn Peninsula in North Wales, exhibit a complicated succession of sediments deposited as result of changes in geoenvironmental conditions over time. Examination of the cliffs has shown that understanding the complex relationship between sediments, climate and slope stability is essential if we are to successfully manage unstable terrain in the region, given that the frequency of extreme climatic events is forecast to increase in the future.

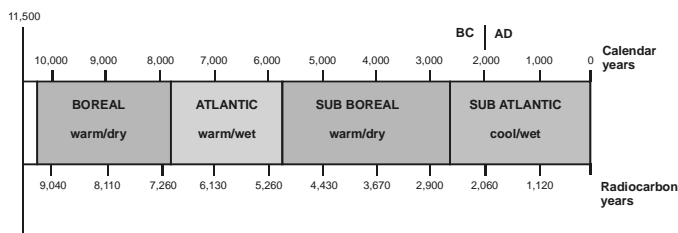
Figure 4. The climatic stages of the Holocene.

It is the climatic changes that have occurred during the Holocene, coupled with the legacy of the glacial and proglacial sedimentary environments that have influenced the style and mechanisms of landsliding in Nefyn Bay today. Several studies have utilized peat records and lacustrine oxygen isotope levels to model a climatic record for the Holocene around the Irish Sea Basin (see for instance Barber *et al.*, 1994, Jones *et al.*, 2002, Marshall *et al.*, 2002, Barber *et al.*, 2003). These demonstrate a significant warming at the end of the Loch Lomond Stadial (approximately 10,000 years ago), which, coupled with sea level rise, have been instrumental in the development of the landslide hazard. Even over the last 10,000 years, there have been wetter climatic conditions than those prevalent today (Fig. 4) and short-lived cold periods such as the “Little Ice Age” during the late 17<sup>th</sup> and 18<sup>th</sup> centuries AD.

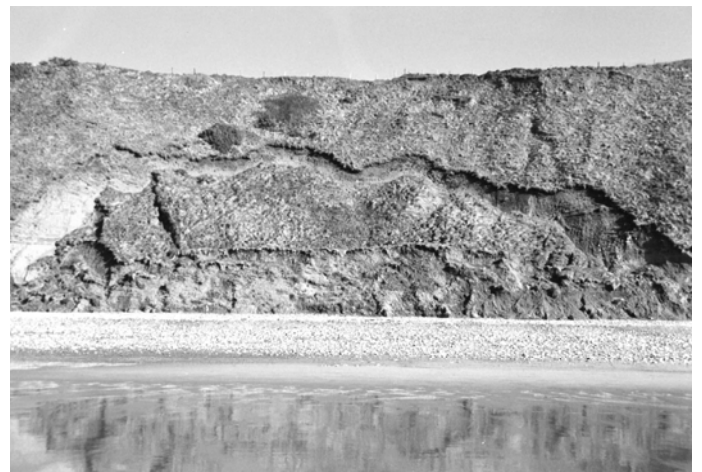
Figure 5. Planar slide at [230950 341150] in the glacio-fluvial sands and gravels.

The relatively weak, permeable nature of sediments in the northern-central part of the bay, laid down in a proglacial environment, have formed steeply graded but vegetated slopes. Failures tend to be shallow planar slides (Fig. 5). One example, recorded in 2001, was over 60 m in width but involved a thickness of material no more than 2 m. Elsewhere in the bay, failures observed within the glacio-fluvial sands and gravels were predominantly small slides and flows, generally less than 0.5 m deep and 1-2 m in length. Such failures are seen over the majority of the slope, often associated with small deposits at the base of the cliff that are removed at very high tides.

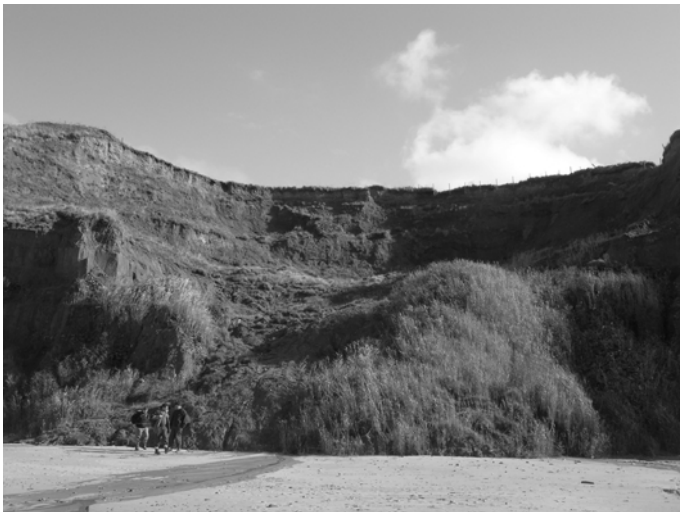
Failures were also associated with filled kettle holes. Figure 6 shows the largest of these, where recent erosion at the base of the cliff has led to a large mudflow. The failure occurred when part of the kettle basin was breached at its seaward side. The removal of lateral support for the sediments within the kettle basin, caused the fine-grained, cohesionless silt fill to fail rapidly and flow out through the breach leaving behind an empty flow bowl.

Figure 6. Kettle hole failure in silts at [230650 340955].

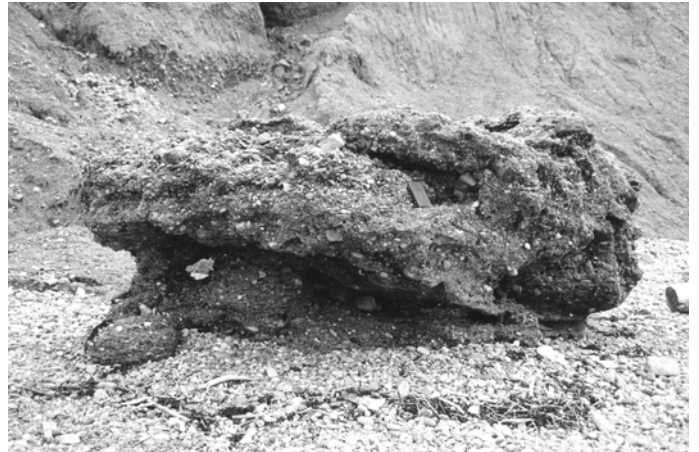
Rockfalls have resulted in the presence of a series of fallen blocks, usually of the indurated cobble-gravel unit on the foreshore (Fig. 7). These blocks, some of which were 4-5 m in diameter, had fallen 10-15 m from the cliff, presumably when support was removed by coastal erosion of supporting sediments.

Figure 7. Fallen block of the indurated cobble gravel unit, indicative of a possible rockfall hazard below the cliffs.

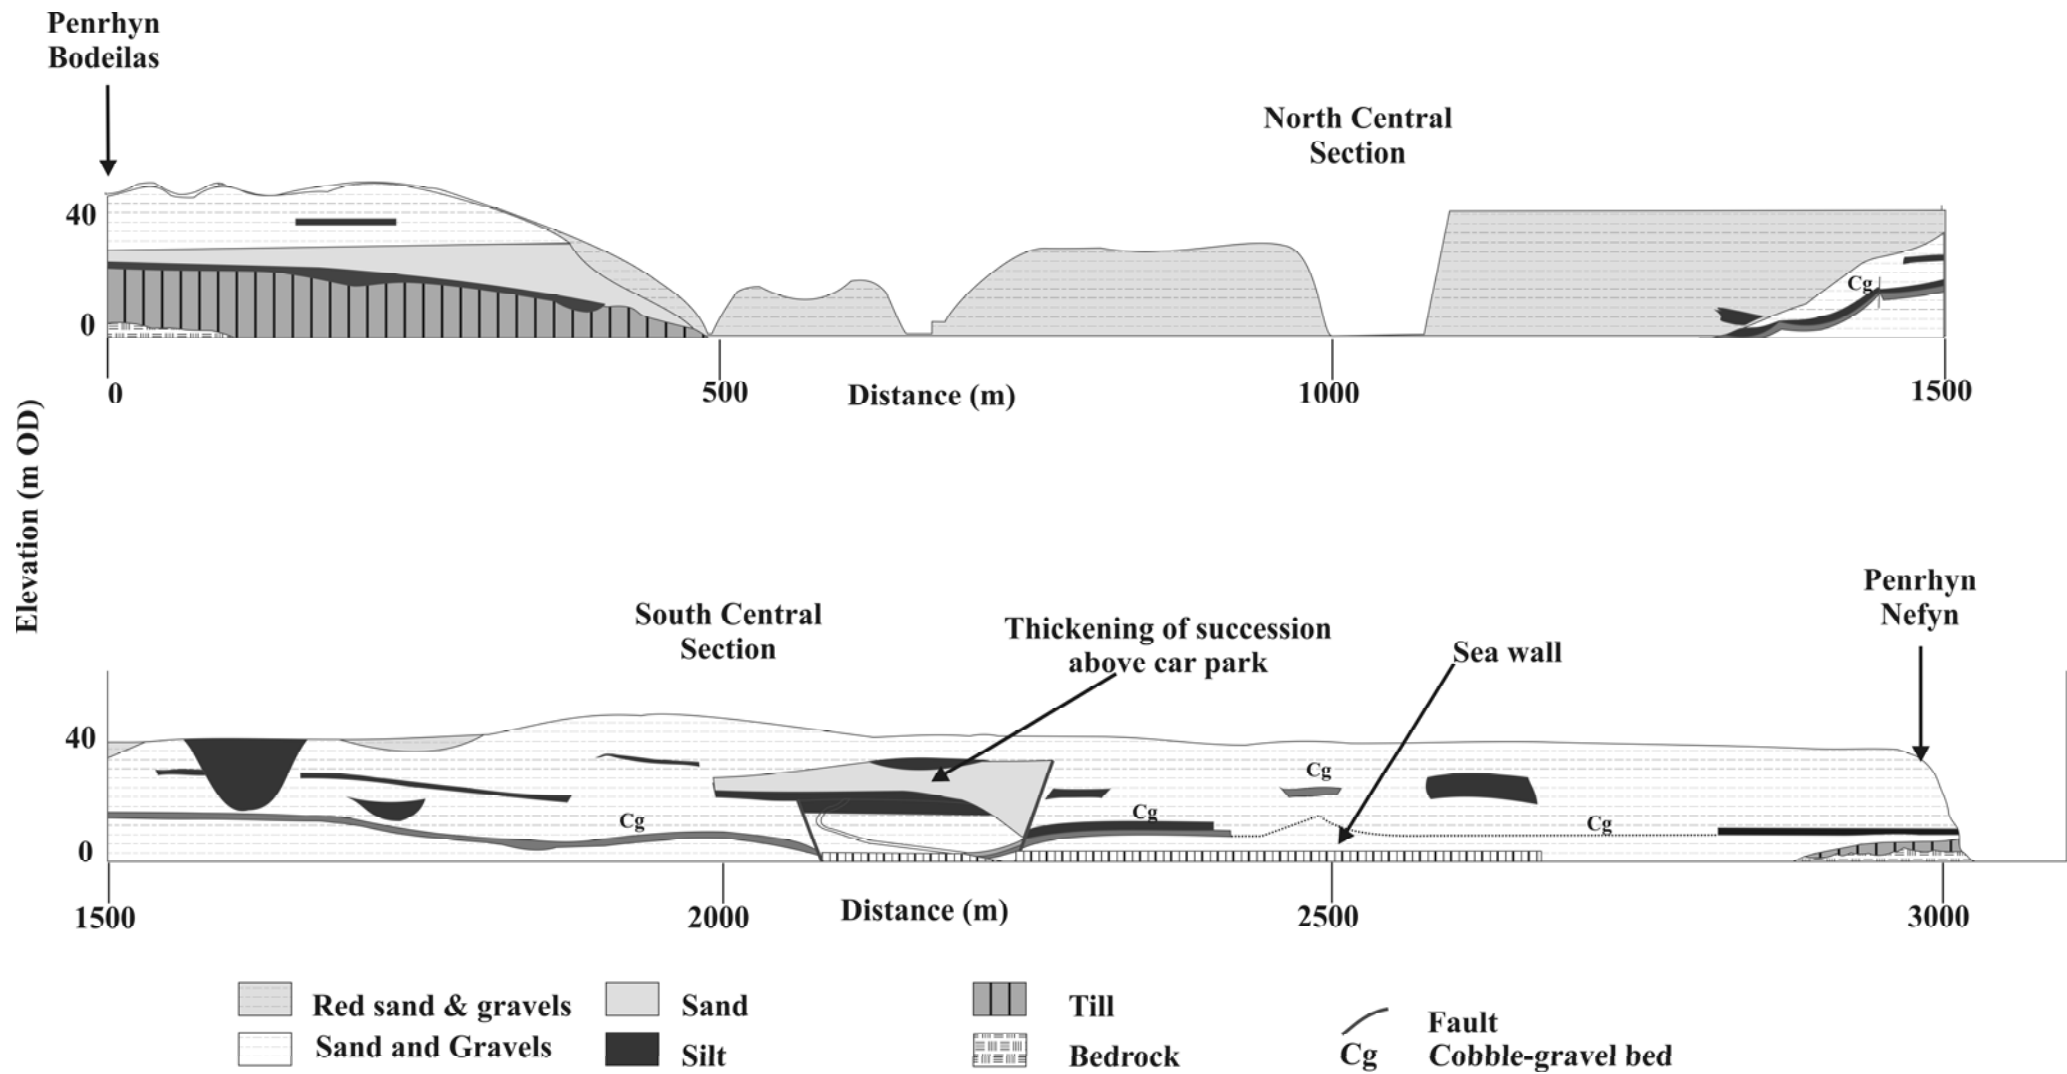
Figure 3. Geological cross section of the cliff section at Nefyn Bay.

The area lies within the British Geological Survey 1:50,000 scale geological map sheet 118 (Nefyn). Bedrock is exposed only at the base of the cliffs on the headlands at each end of the bay (Fig. 3). At Penrhyn Bodeilas, bedrock is composed of a coarse-grained granite of unknown age, whereas the headland at Penrhyn Nefyn is composed of Precambrian metamorphosed granites and Ordovician shales. These metamorphic rocks are also believed to underlie the length of Nefyn Bay but are not exposed.

cliff at Penrhyn Bodeilas, and to the south-west, where it overlies the southern-central deposits described above. This succession appears to be infilling an erosional channel or large basin which has been eroded into the till and older deposits to the south-west (Figure 3).
