Chapter 5

Discussion

5.1. Introduction

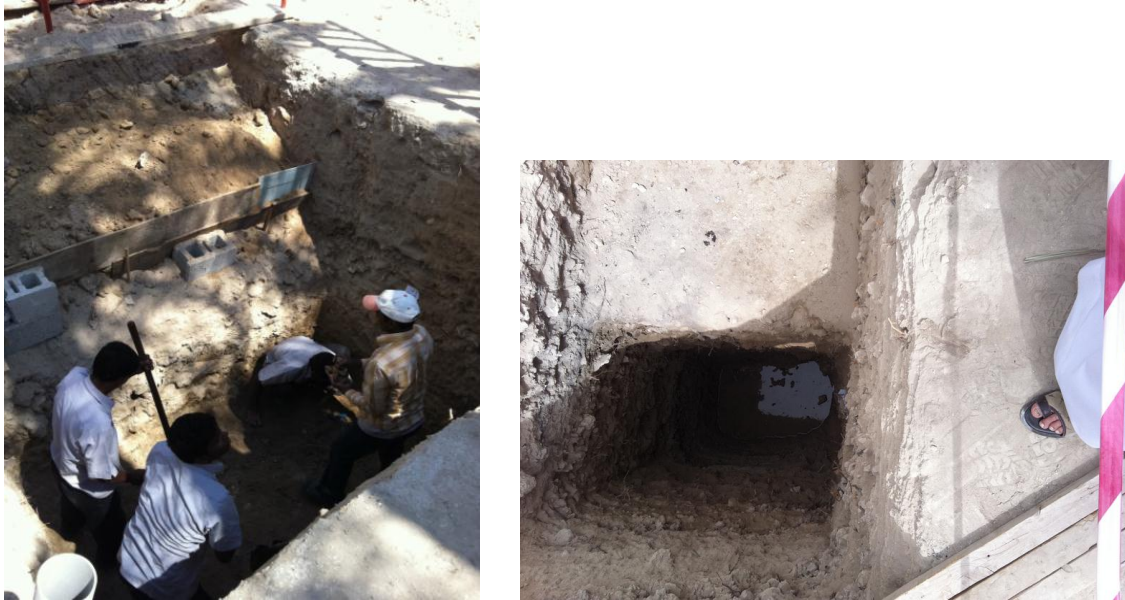
Fig 5.1. Excavation at Sheikh Salman house, showing the ground water at around 4.5 meter depth.

Subsequently the town expanded onto the main Muharraq island and consolidated the capital. The town was surrounded by a matchlock defence wall to protect against any aggression. This is proven by demonstrating the second and third phases or cores of settlement over the high points on the main island of Muharraq. During that time the main island used to have six prominent mounds and the rulers first established the town of Muharraq atop one of those mounds in the centre of island. It was determined through digital terrain modelling techniques which demarcated the six mounds. These are otherwise completely obscured by dense urbanization and lack of any written accounts about them. The only supporting account was provided by an elderly citizen who had some vague idea passed onto him by his forefathers. During one of the recent excavations by my team, as shown in fig 5.1, it was established that the initial buildings of the rulers were indeed built on top of those mounds. This excavation was performed

behind one of the famous houses, Sheikh Hamad house, where the team encountered ground water at almost five meter from the ground level, confirming the height of the region.

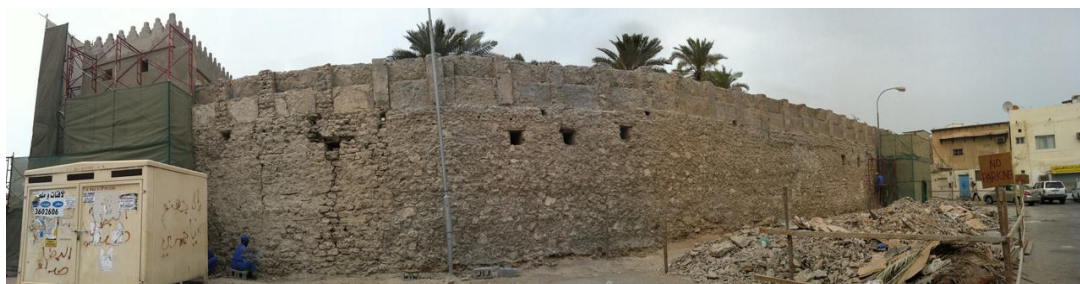
Fig 5.2 Sheikh Salman house as it exists now in dilapidated condition.

Sheikh Salman house is one of the oldest surviving buildings, which was built when the ruling family moved from Bu Maher to the main island of Muharraq. This house was approximately built around 1820 (Fig 5.2). This house, which has been uninhabited for a long time, and has deteriorated due to poor maintenance, has now been one of the top priorities for the restoration, as shown in Photo 5.3. The building is being restored with its original architecture using original construction materials and specially trained masons and craftsman, working under my supervision for the Ministry of Culture, Bahrain.

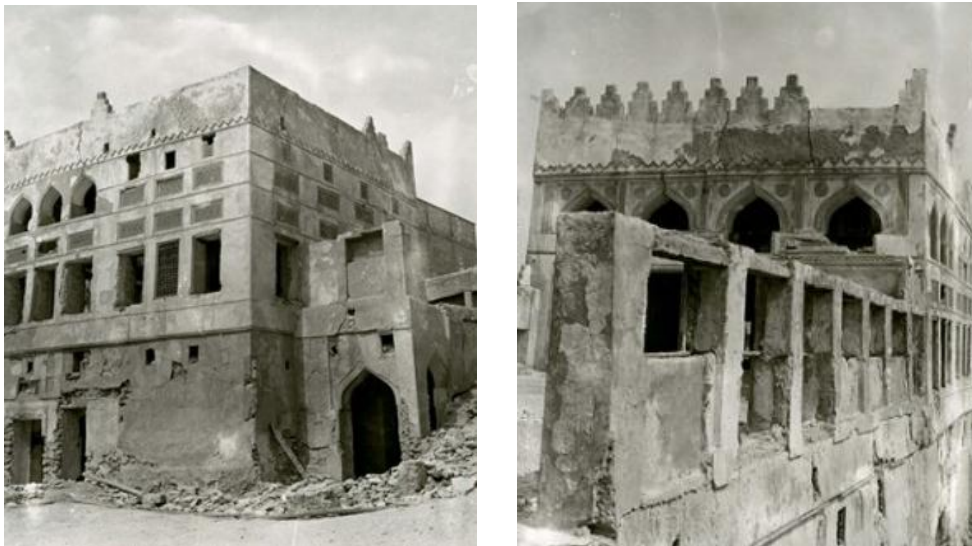
Fig 5.5 Photographs of the Sheikh Hamad house in ruins, prior to its demolition.

One of the most important buildings being planned for reconstruction is the Sheikh Hamad house, the first house built in the second core of Muharraq. The house, which was in ruins, was demolished in the mid 1980s to pave way for widening of the streets. Figure 5.5 shows the photographs of house prior to demolition. Now, based on my recommendations justifying the importance of the house, the government is initiating a project to reconstruct the house. For this I created a digital model of the house using the photographs and description in the document as shown in Fig 5.6. Currently finer details are being worked out and plans are being drawn prior to commencing actual reconstruction at its original location.

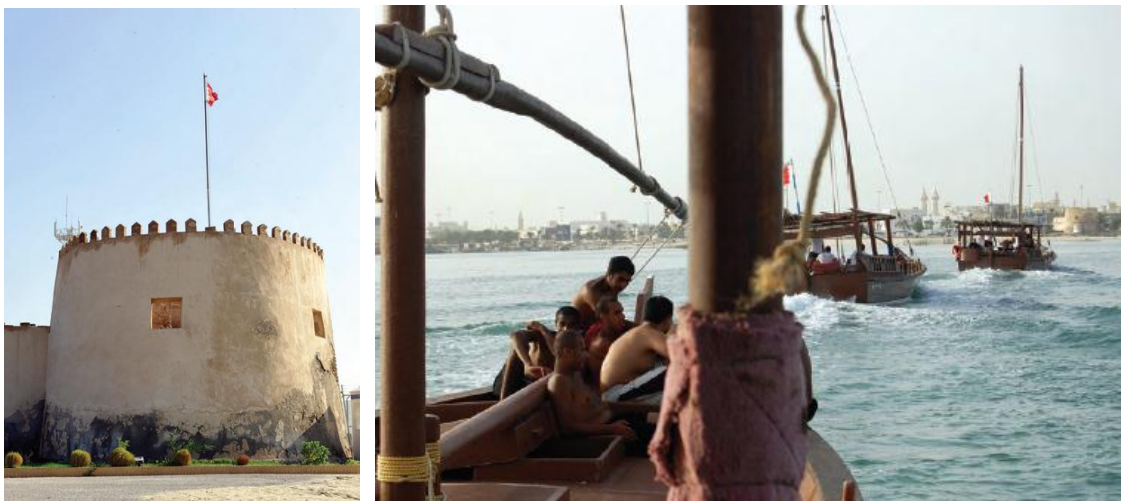
Fig 5.7 The only surviving tower of Bu Mahir fort, and on the right are the fishing boats returning to harbour towards Bu Mahir fort in the far distance.

Another important landmark in Muharraq is the fort of Bū Māhir which has been in existence since the 16th century, but currently only one of the four towers remains as shown in figure 5.7. The fort has been the most crucial defensive structure for the first core of Muharraq, which is now Bu Maher. It was important for the protection of pearling fleets into the harbour. It protected the main water source of Muharraq City, an underwater sweet water spring located in the adjacent sea which nowadays is found active only sporadically. After the peace in the region the defence function ceased to play a role and the decline of the fort began. However, it remained important as a viewpoint during the *rakbah* and *quffāl* festivals signifying the return of pearling fleets or bidding them farewell on their departures. The people would climb the ruins to gain a better view (fig 5.7) of the fleets. The fort thus became an important memory marker of these important events in history. Justifying this historical significance it has been recommended strongly to reconstruct the lost portion of the fort for which I have created a digital model of the fort from sketches and descriptions of the fort drawn by various sailors, as shown in fig 5.8.

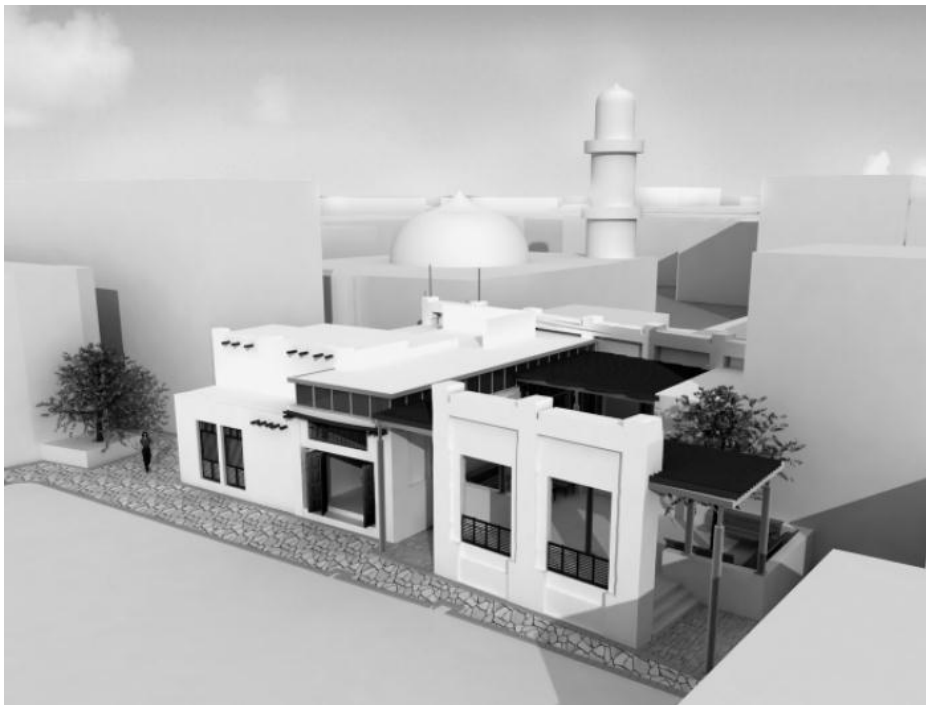
5.10 Artistic design for restoration of the Suq al Qaysariya to revive its lost significance and glory.

The Suq is an integral part of an Islamic town, and in Muharraq, it is **Suq** al-Qaysariya which has been in existence since the town evolved. The Suq itself is significant architecturally with its shared back walls, opening vistas, careful overall architectural expression despite the topographic differences, and many other hidden societal qualities that were the bases of development. Practicality and efficiency are core distinguishable features, and the physical output is rather homogeneous and compatible with the environment. But since it lost its link to the seashore, it began losing its functional significance and old prominence. In this effort, I have already initiated plans to revitalize the suq and bring it to prominence for the benefit of local people and tourism. Already a design has been developed and very soon the project will be realized for its reconstruction.
