Environmental Stress cracking of polymers: case studies from industry (ABS and LDPE)

Thomas Doohar, Abu Saifullah, Jawad Ullah, Ciaran Magee, Adrian Mulholland & Dorian Dixon

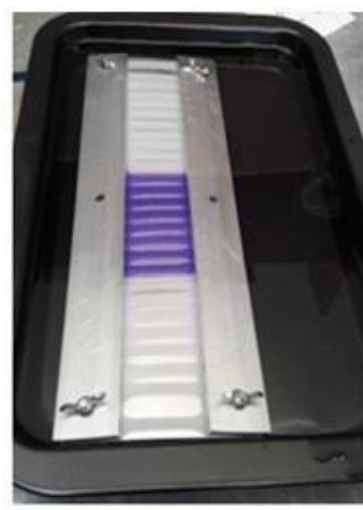
B

Figure 5. Samples inserted into holders: ASTM standard (A) painted and (B) dip-in test and ISO bent strip standard (C) dip-in test
